NBSIR 74-390

ELECTROMAGNETIC NOISE IN ITMANN MINE

Electromagnetics Division
Institute for Basic Standards
National Bureau of Standards
Boulder, Colorado 80302

June 1974

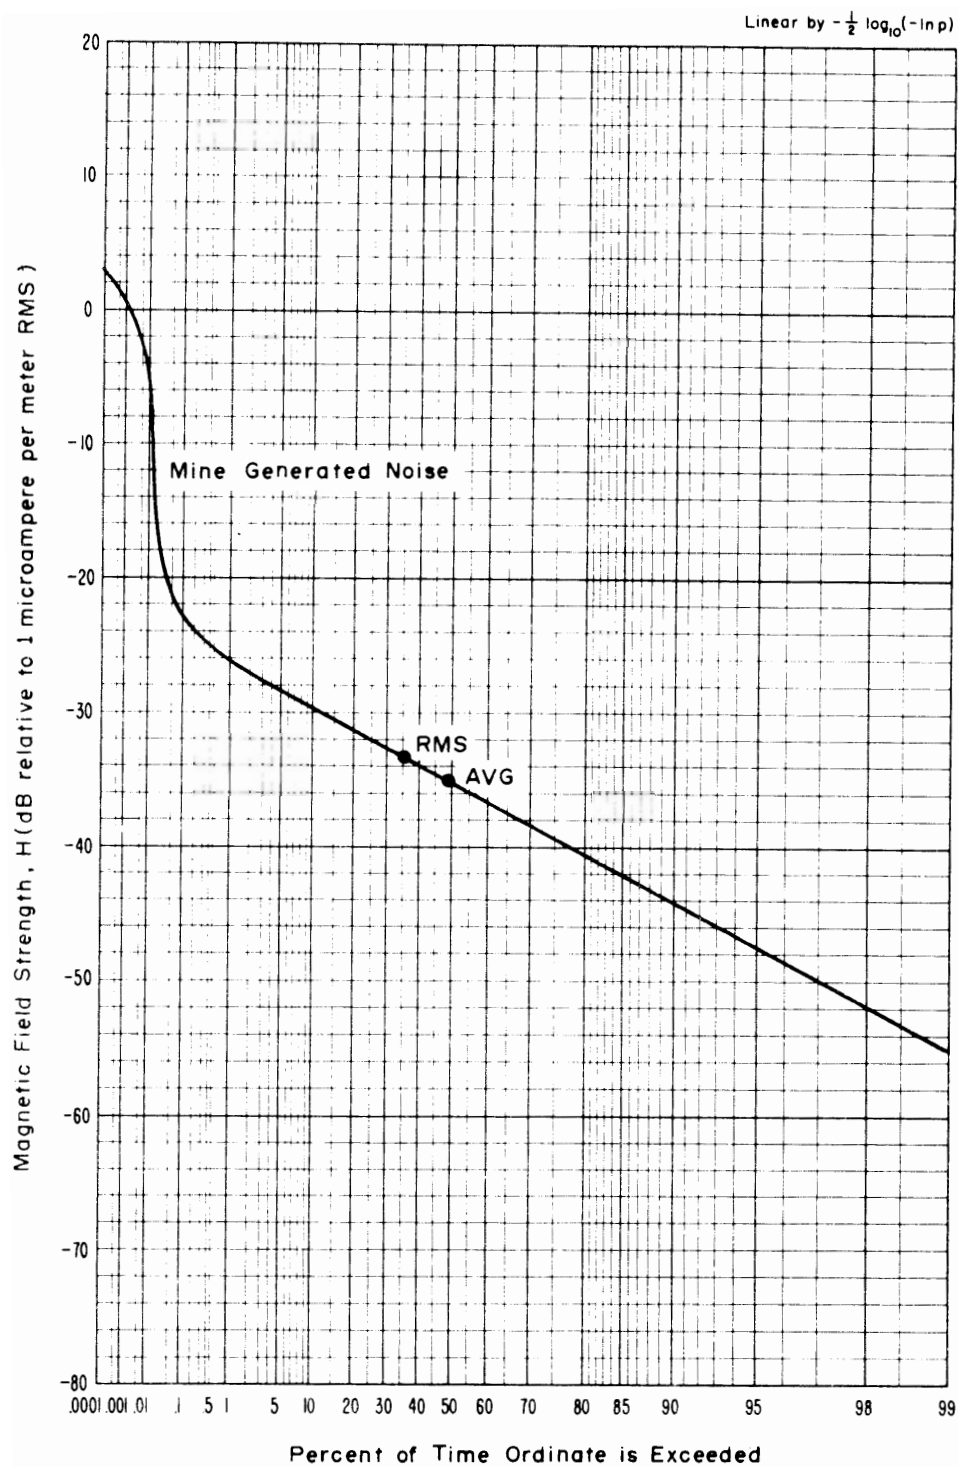
Figure 4-8 APD, 1 MHz, vertical component, 1.2 kHz predetection bandwidth, April 17, 1973, 12:20 p.m., Cabin Creek, Itmann #3.

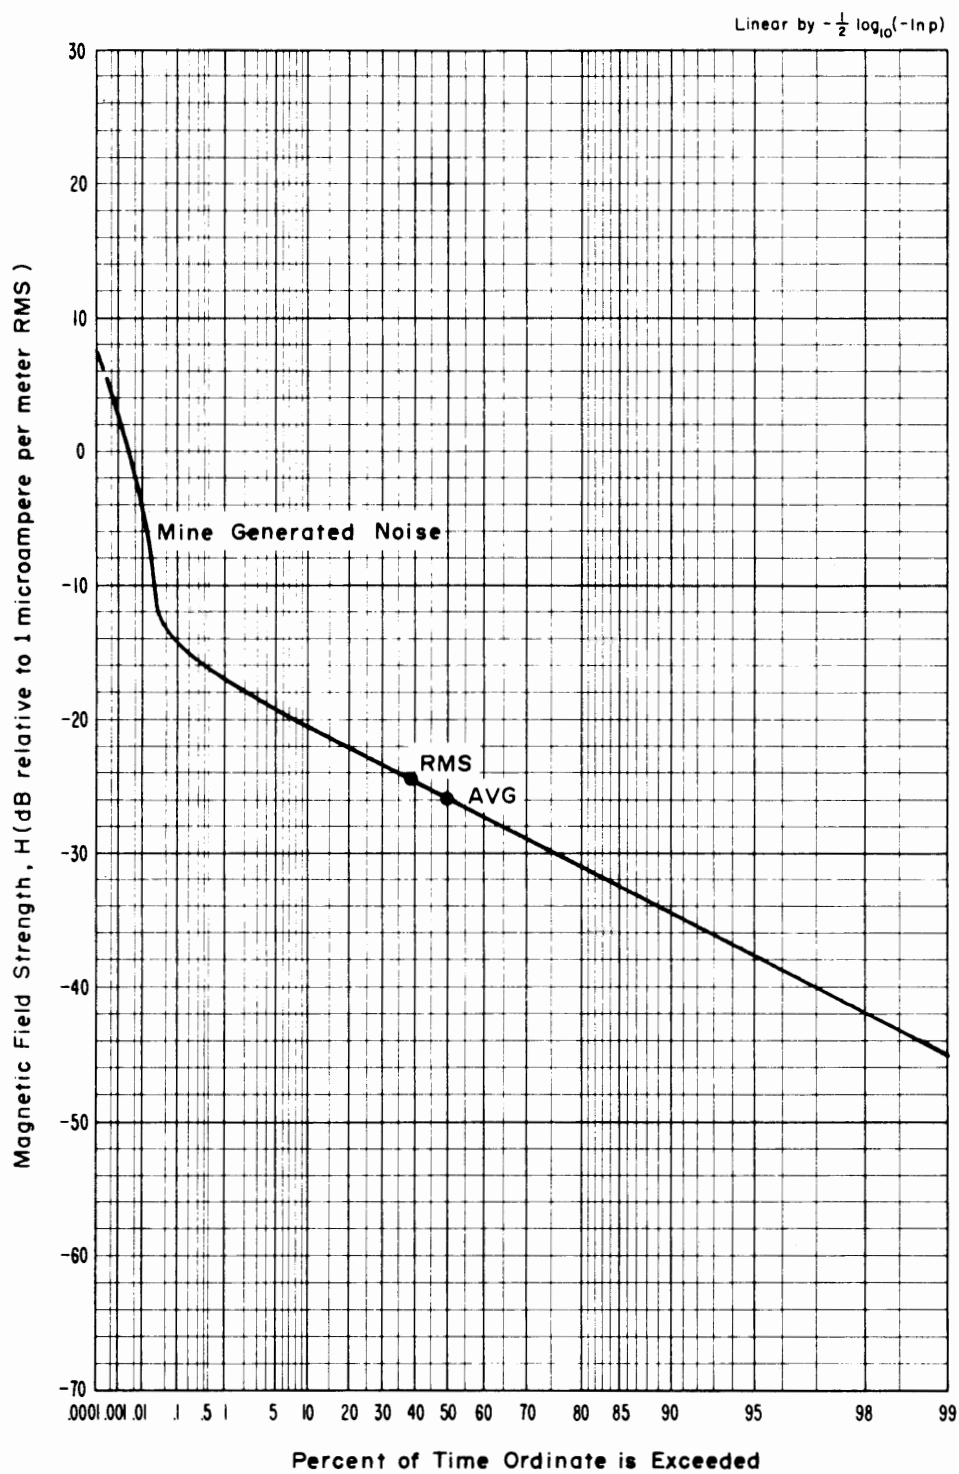
Figure 4-9 APD, 2 MHz, vertical component, 1.2 kHz predetection bandwidth, April 17, 1973, 12:50 p.m., Cabin Creek, Itmann #3.

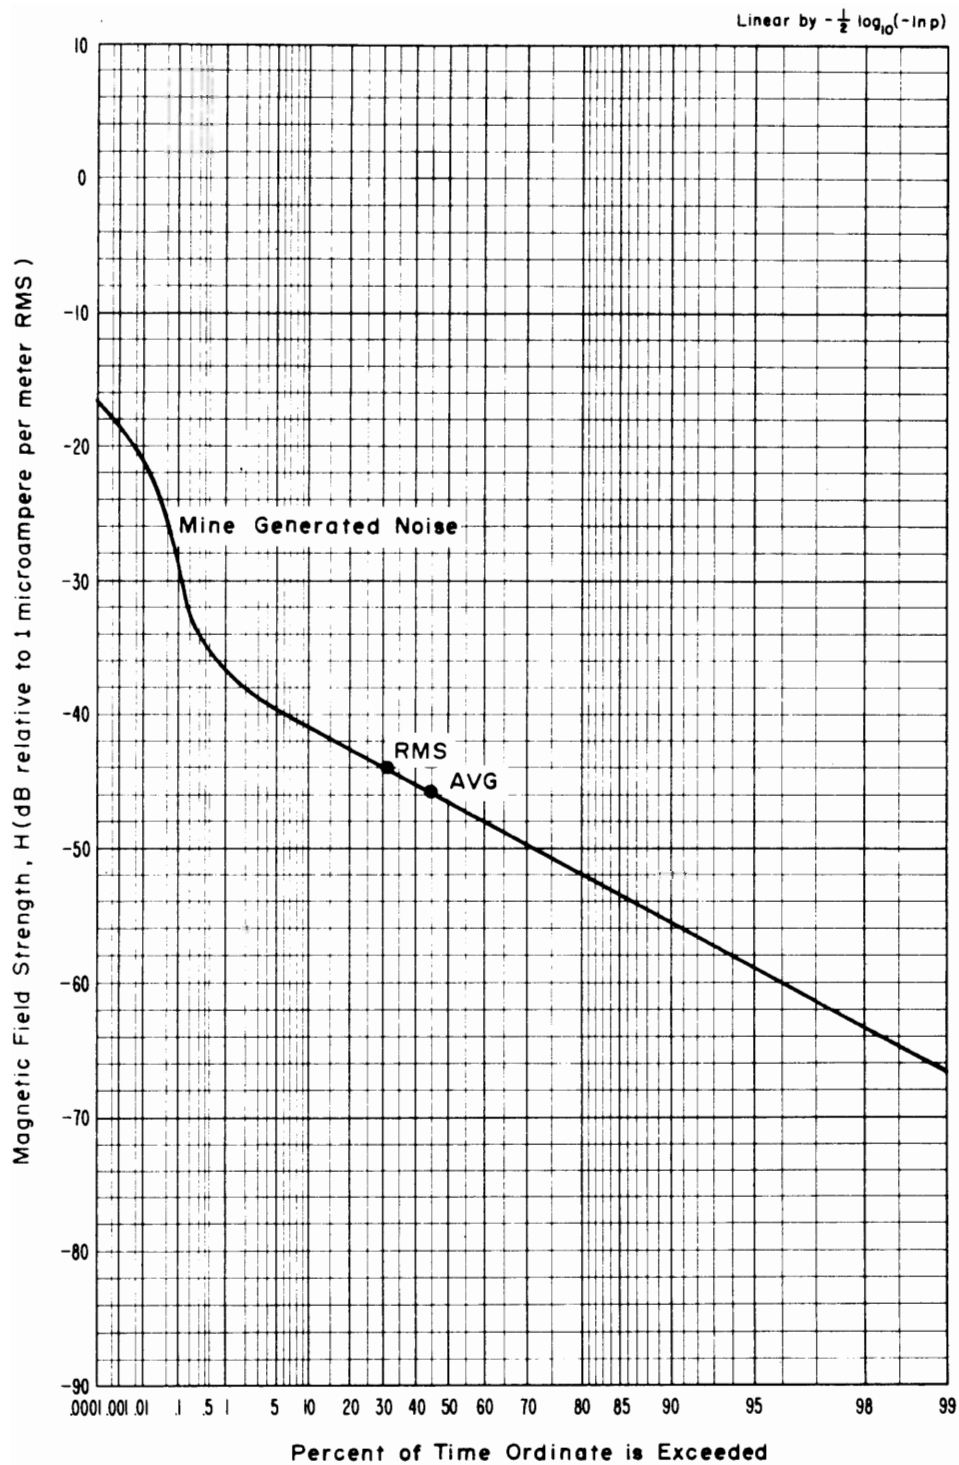
Figure 4-10 APD, 6 MHz, vertical component, 1.2 kHz predetection bandwidth, April 17, 1973, 1:30 p.m., Cabin Creek, Itmann #3.

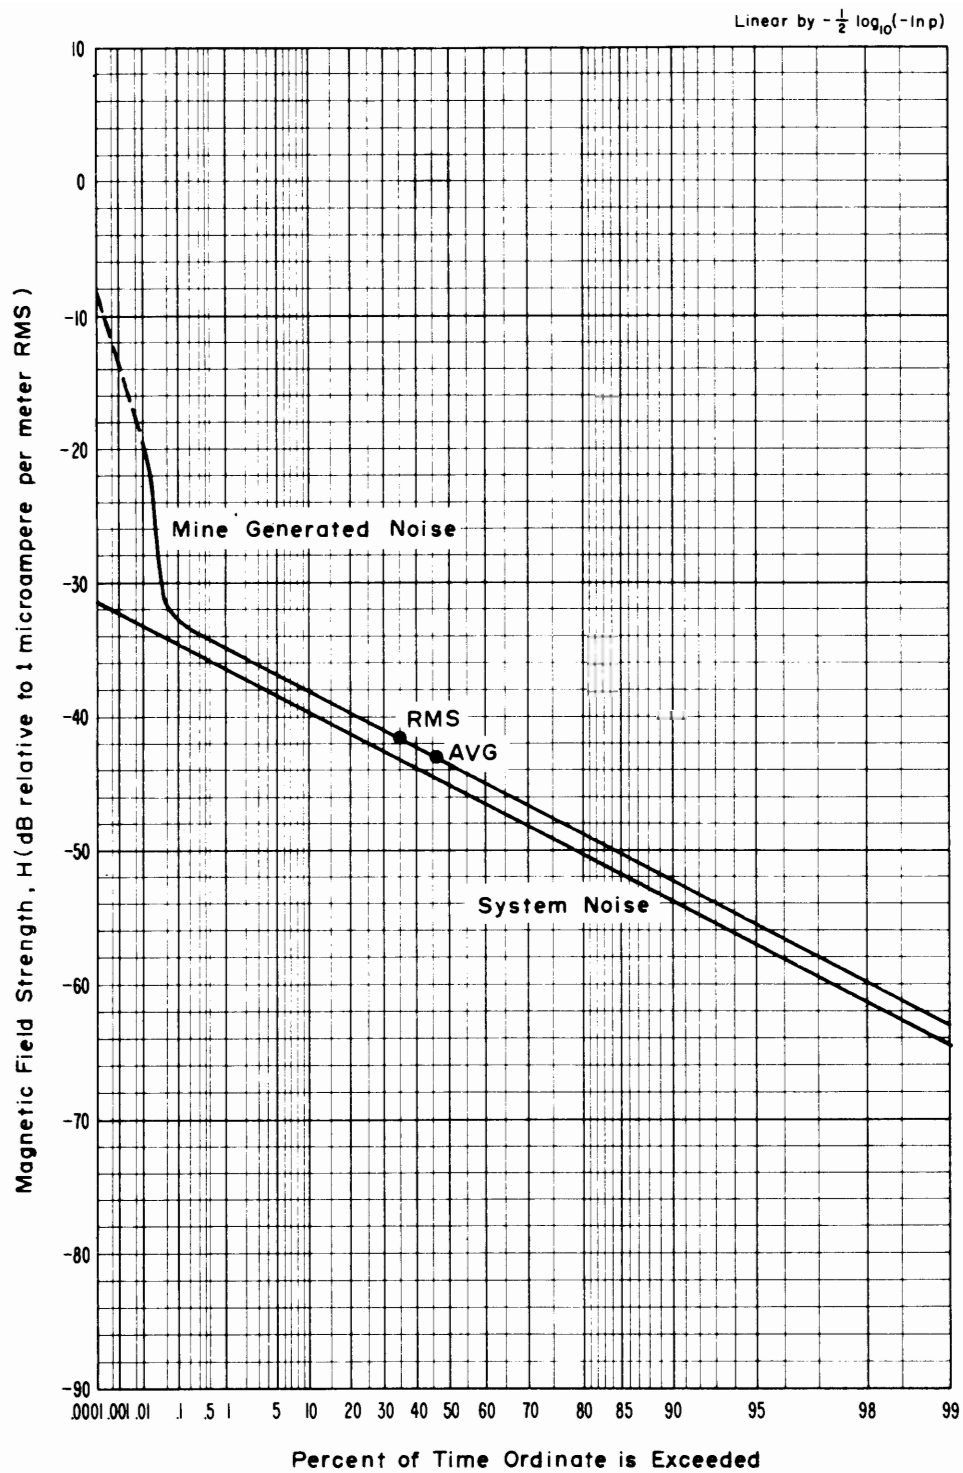
Figure 4-11 APD, 14 MHz, vertical component, 1.2 kHz predetection bandwidth, April 17, 1973, 2:20 p.m., Cabin Creek, Itmann #3.

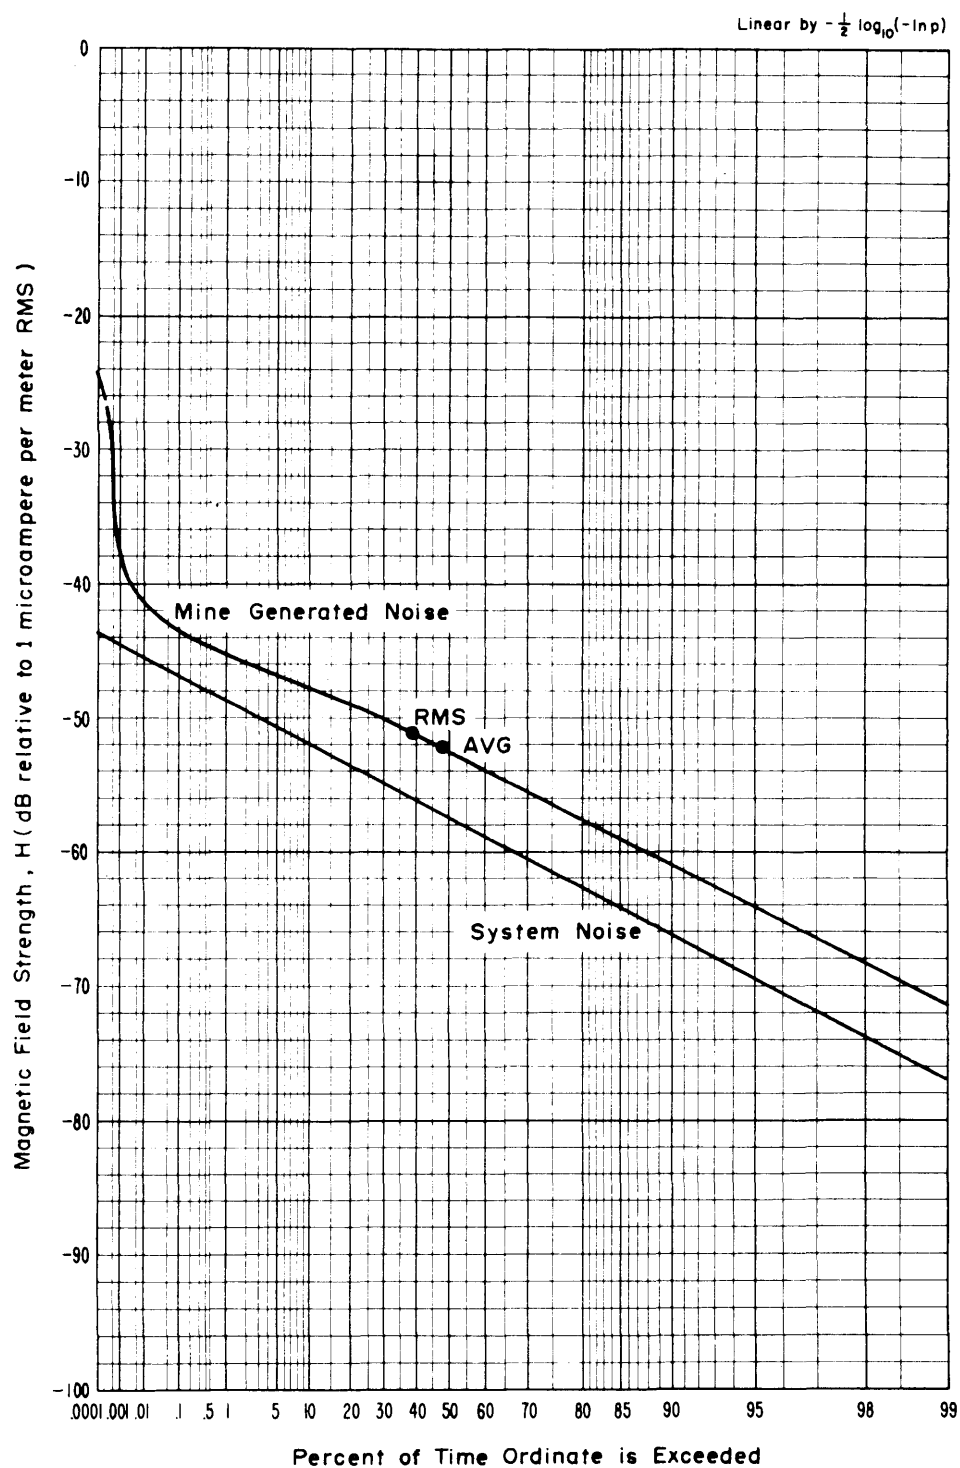
Figure 4-12 APD, 32 MHz, vertical component, 1.2 kHz predetection bandwidth, April 17, 1973, 3:00 p.m., Cabin Creek, Itmann #3.

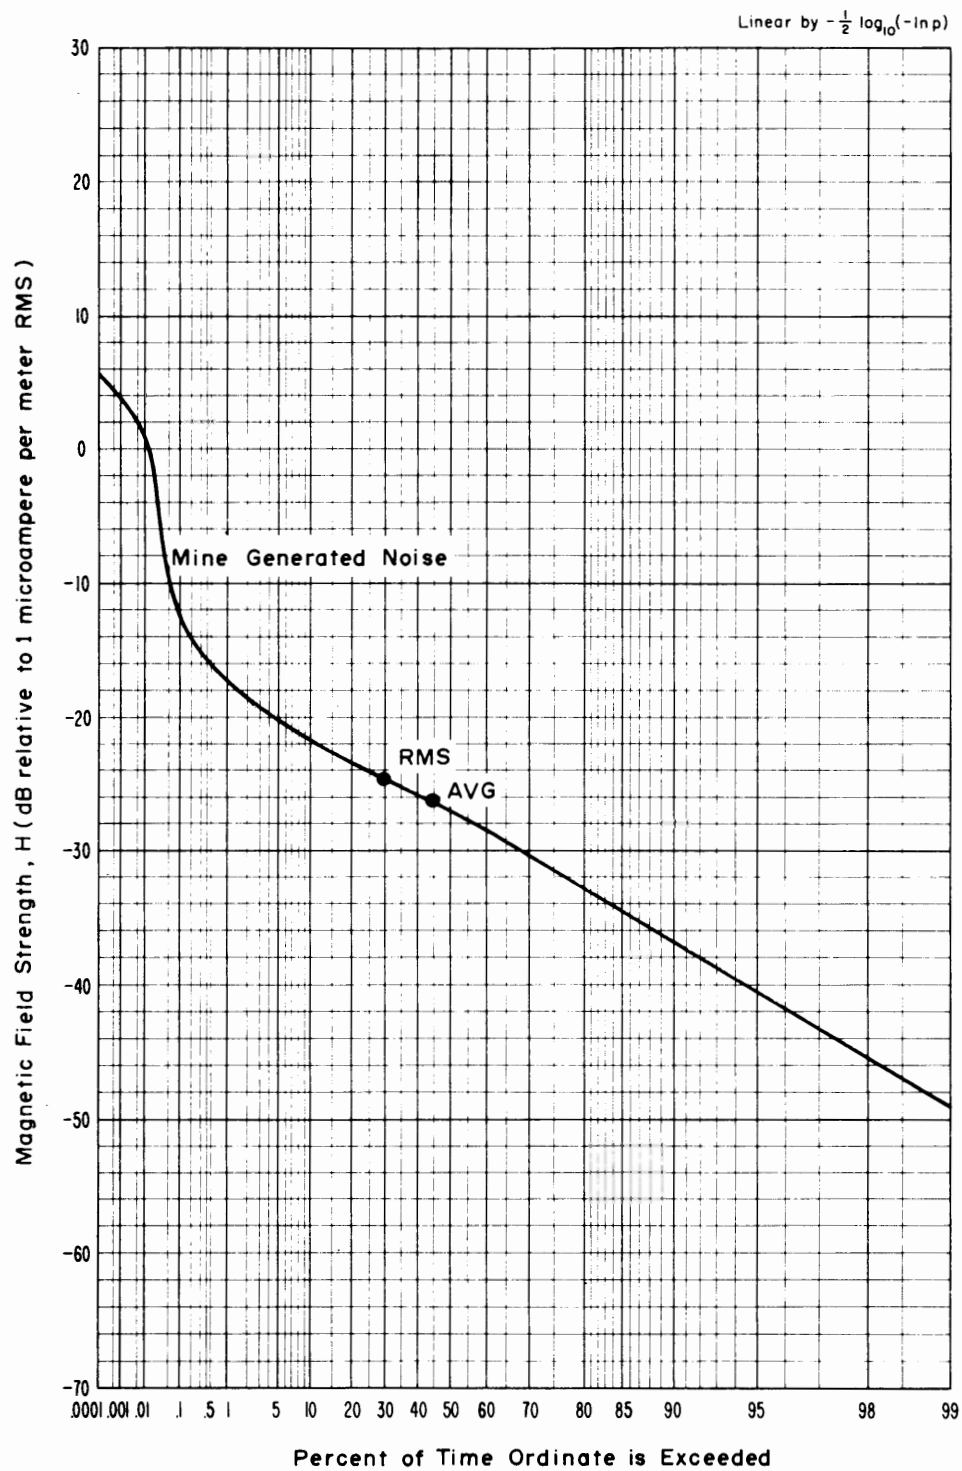
Figure 4-13 APD, 10 kHz, vertical component, 1.0 kHz predetection bandwidth, April 17, 1973, 3:40 p.m., Quiet Time Measurement, Cabin Creek, Itmann #3.

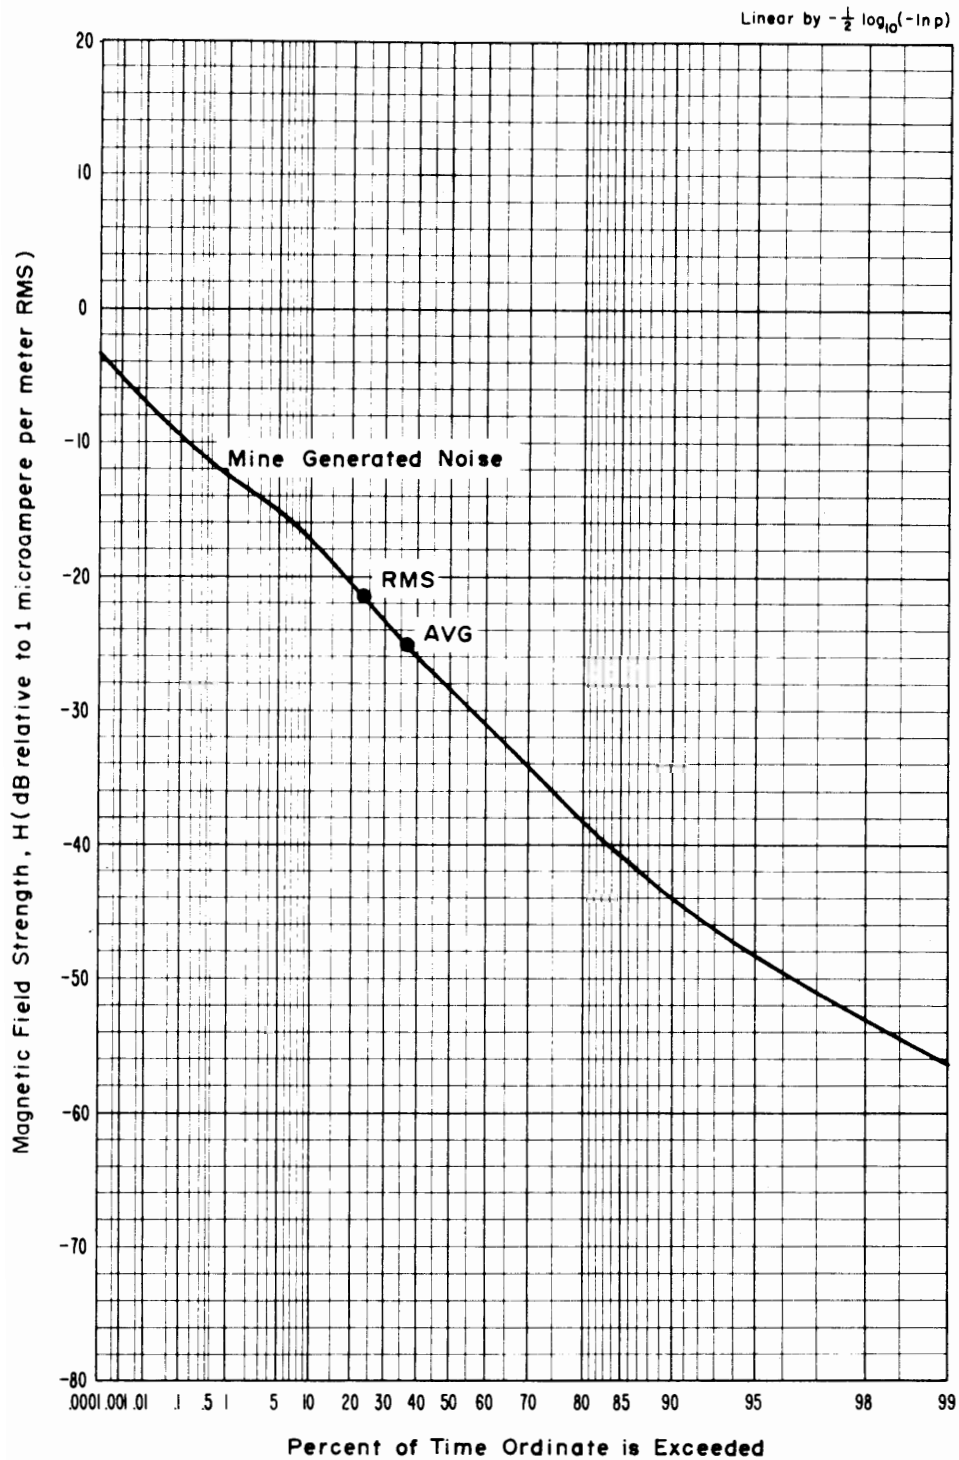
Figure 4-14 APD, 30 kHz, vertical component, 1.0 kHz predetection bandwidth, April 17, 1973, 3:50 p.m., Quiet Time Measurement, Cabin Creek, Itmann #3.

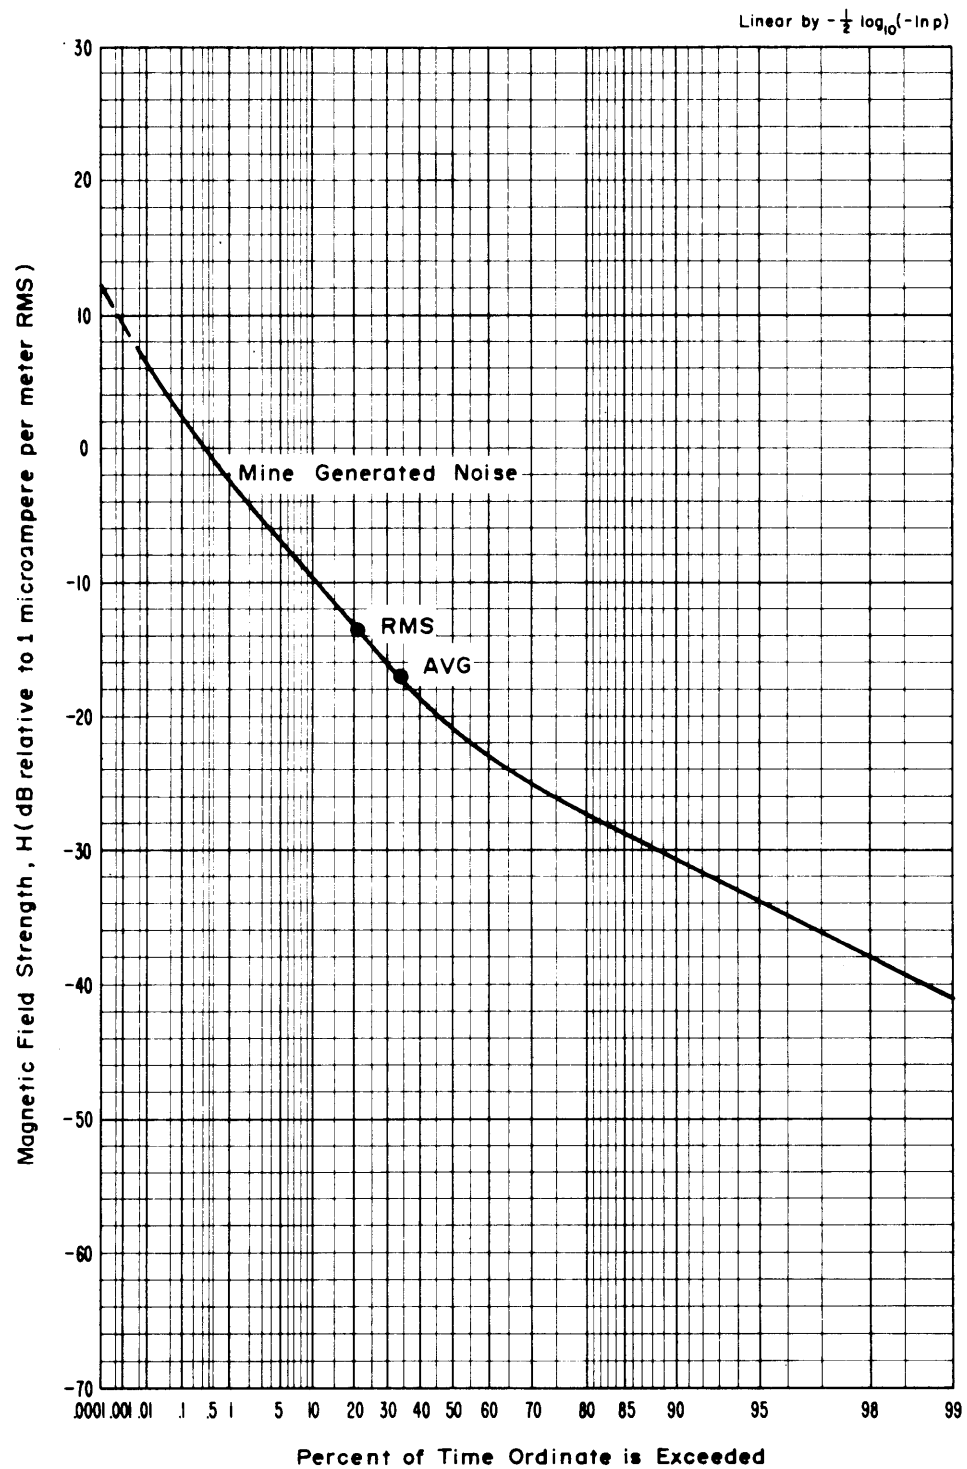
Figure 4-15 APD, 130 kHz, vertical component, 1.0 kHz predetection bandwidth, April 17, 1973, 4:05 p.m., Quiet Time Measurement, Cabin Creek, Itmann #3.

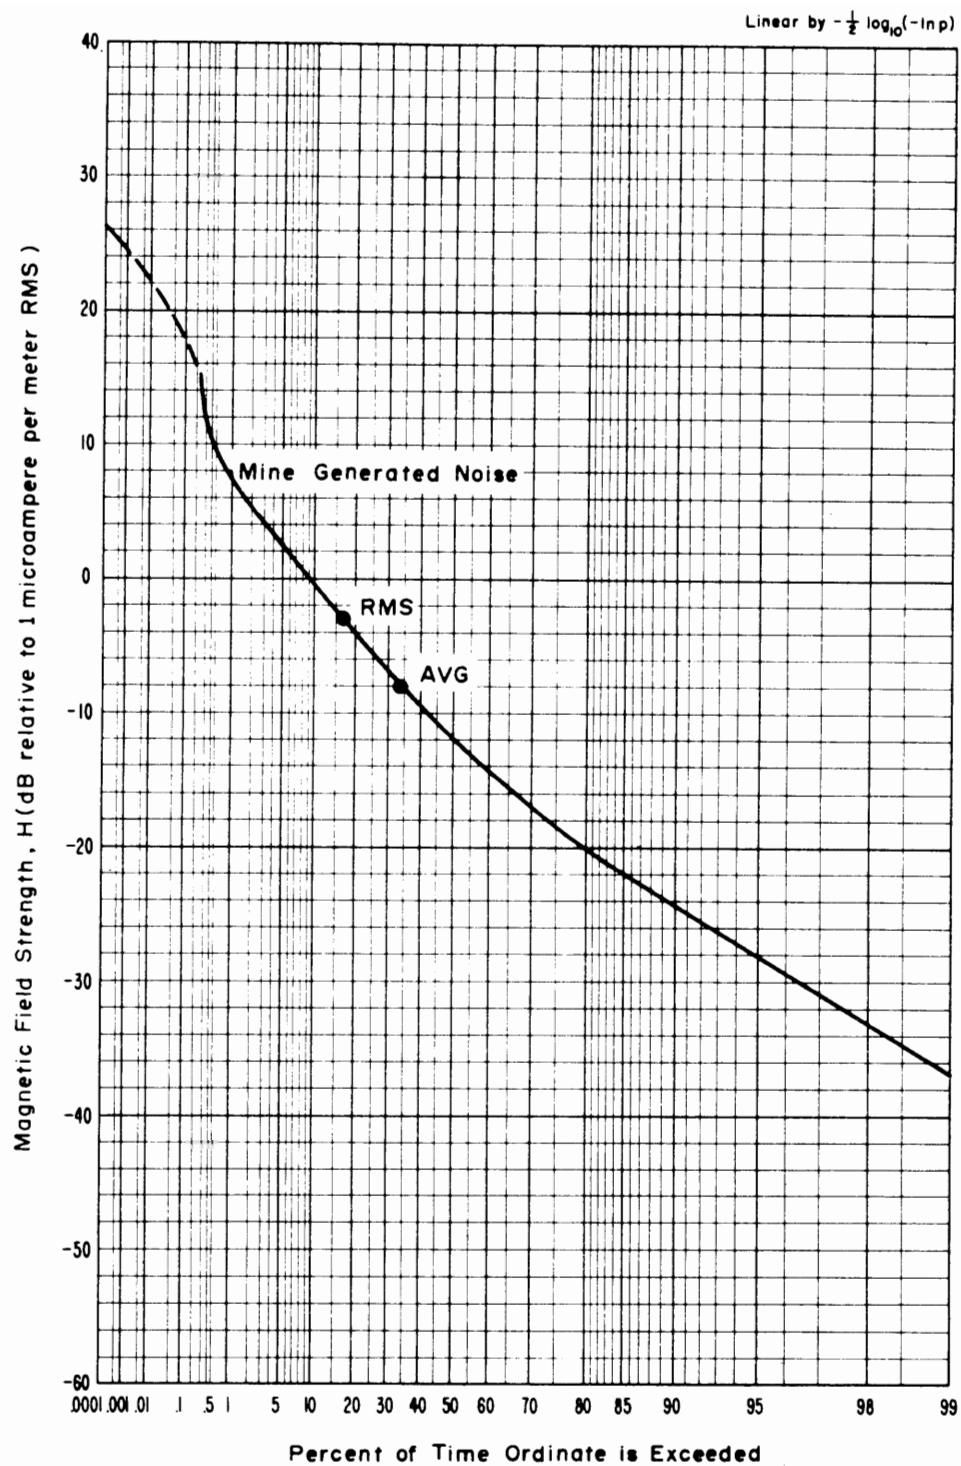
Figure 4-16 APD, 500 kHz, vertical component, 1.2 kHz predetection bandwidth, April 17, 1973, 3:40 p.m., Quiet Time Measurement, Cabin Creek, Itmann #3.

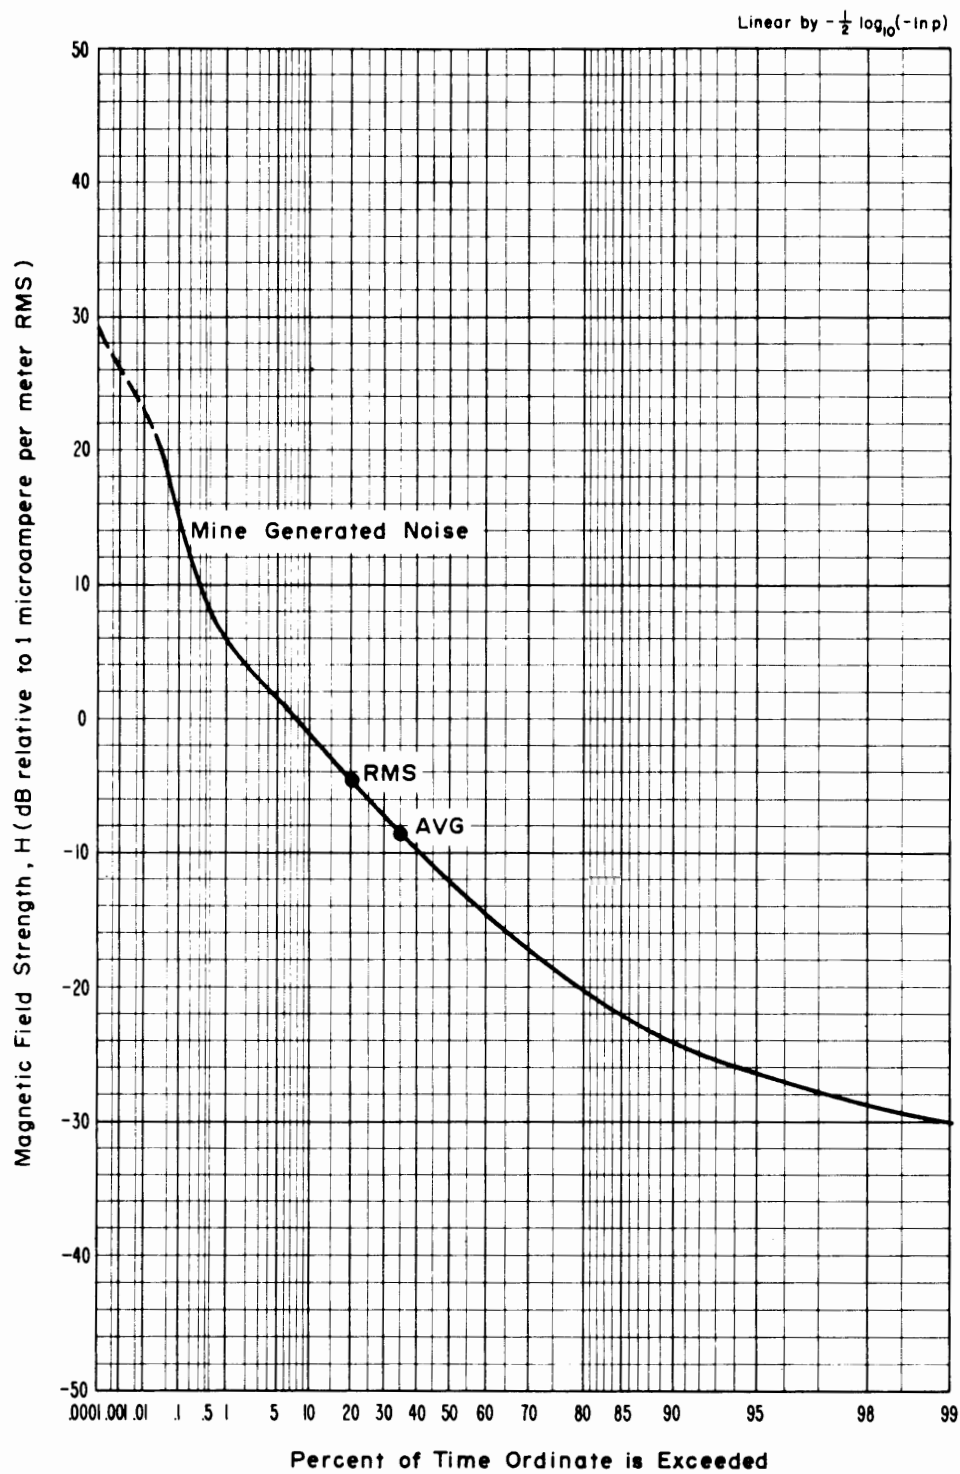
Figure 4-17 APD, 1 MHz, vertical component, 1.2 kHz predetection bandwidth, April 17, 1973, 3:50 p.m., Quiet Time Measurement, Cabin Creek, Itmann #3.

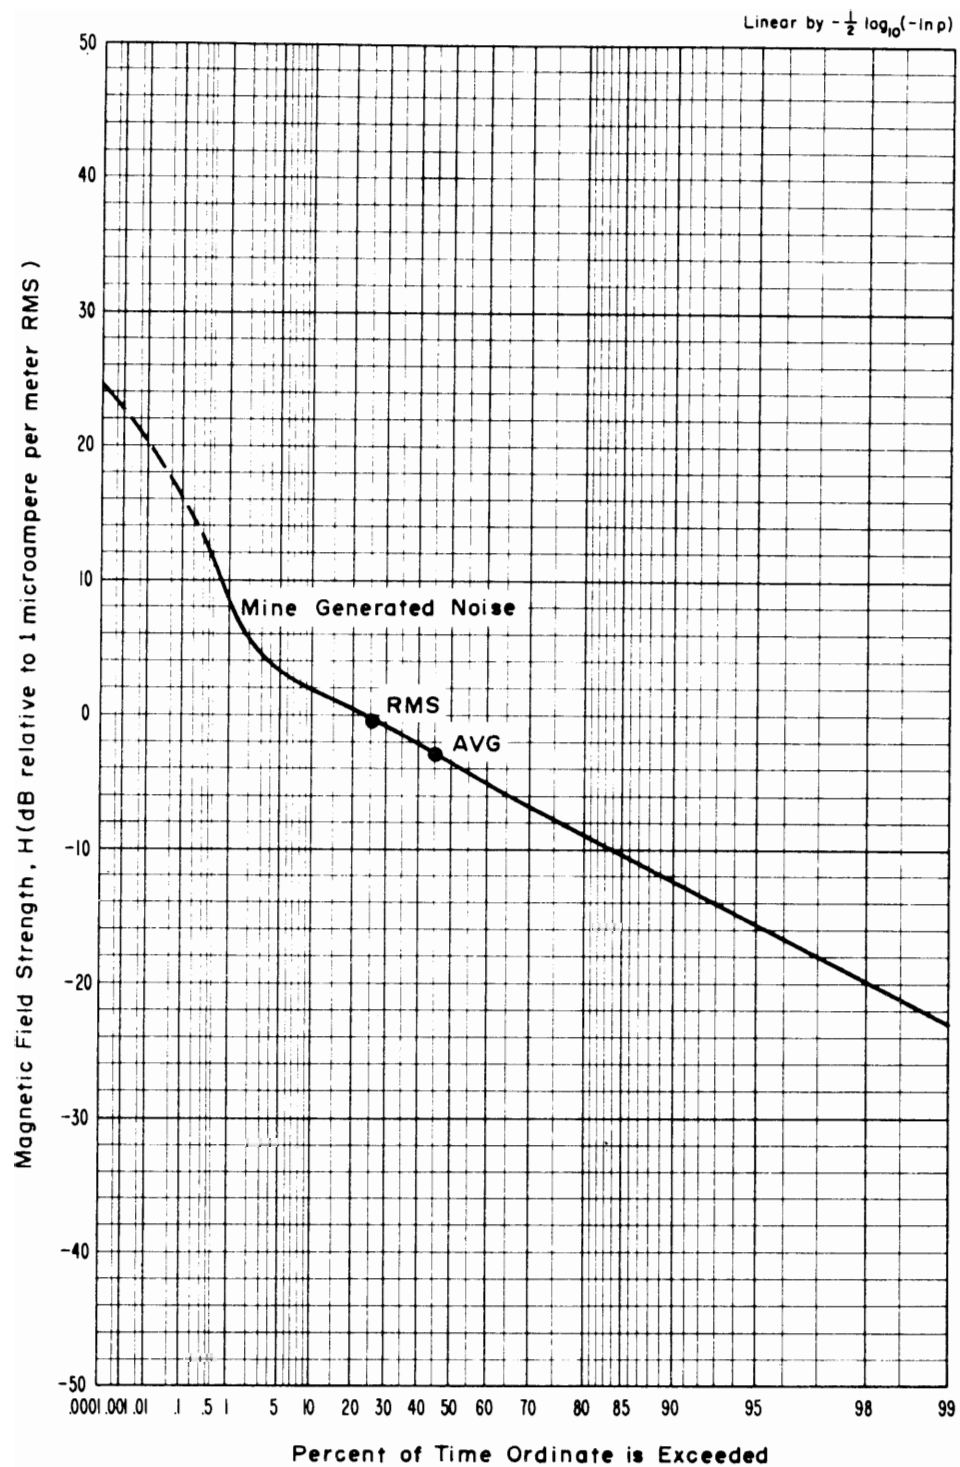
Figure 4-18 APD, 2 MHz, vertical component, 1.2 kHz predetection bandwidth, April 17, 1973, 4:00 p.m., Quiet Time Measurement, Cabin Creek, Itmann #3.

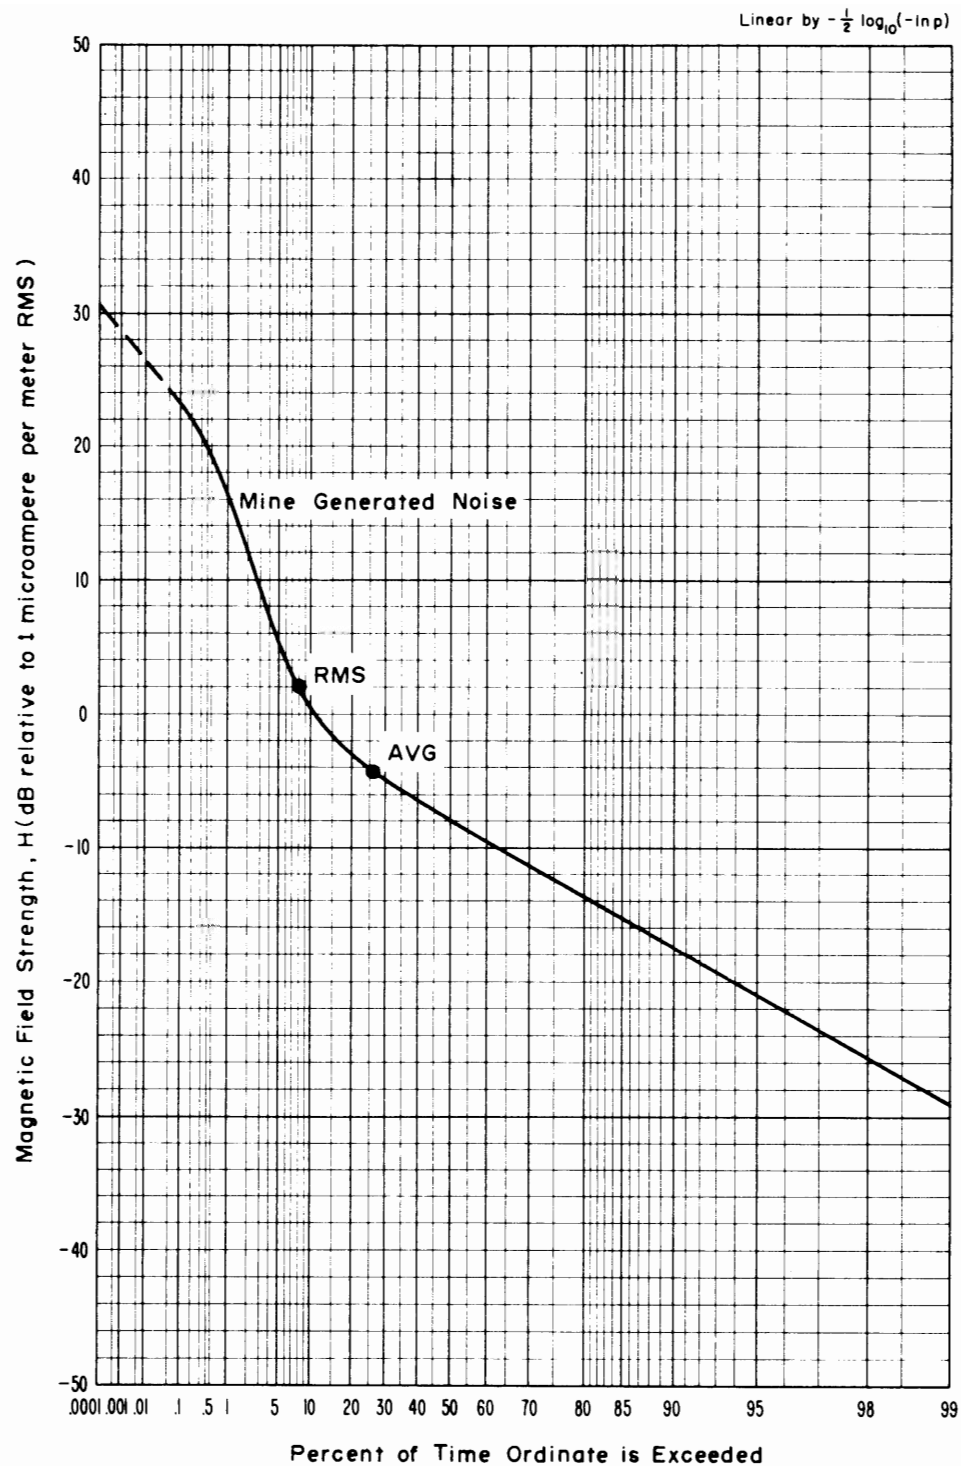
Figure 4-19 APD, 6 MHz, vertical component, 1.2 kHz predetection bandwidth, April 17, 1973, 4:05 p.m., Quiet Time Measurement, Cabin Creek, Itmann #3.

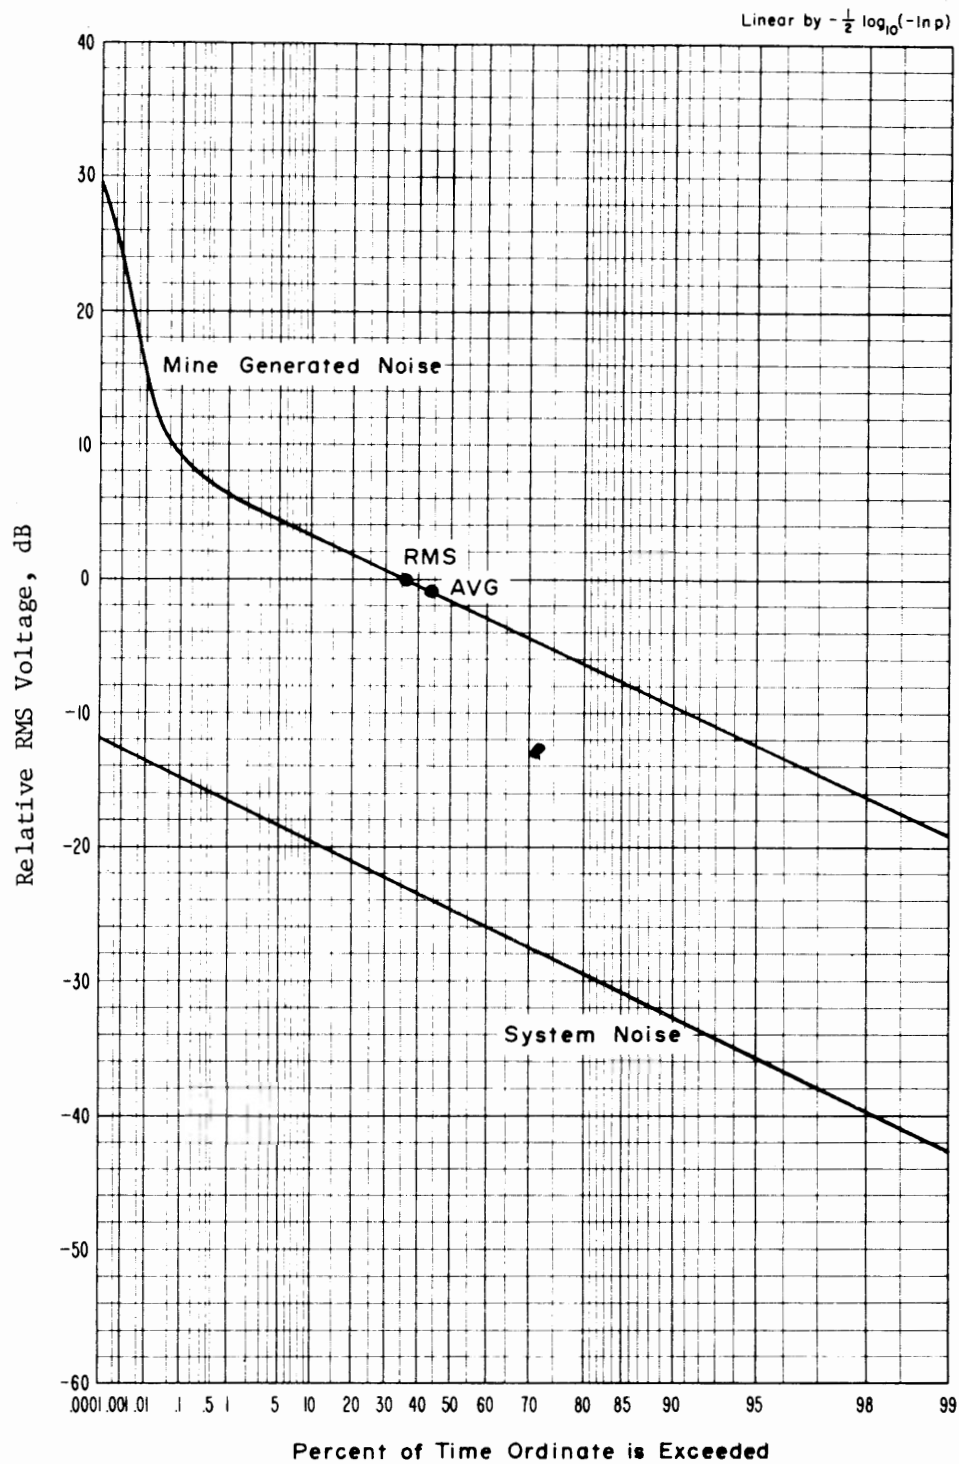
Figure 4-20 APD, 10 kHz, roof bolt measurement, 1.0 kHz predetection bandwidth, April 17, 1973, 5:00 p.m., Cabin Creek, Itmann #3.

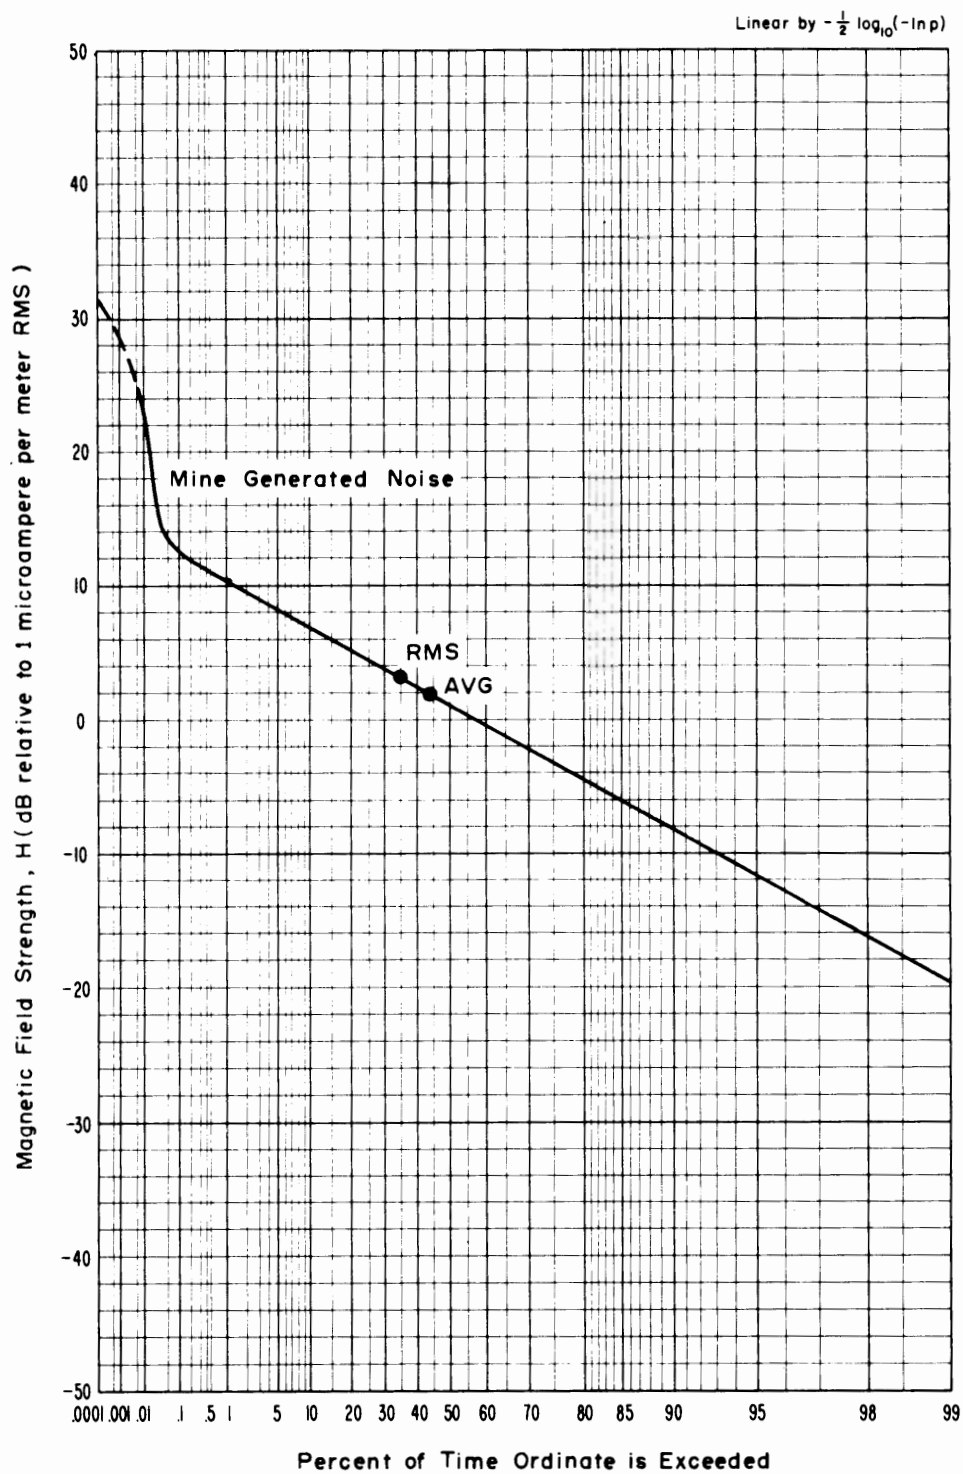
Figure 4-21 APD, 10 kHz, vertical component, 1.0 kHz predetection bandwidth, April 17, 1973, 12:30 p.m., Farley Panel, Itmann #3.

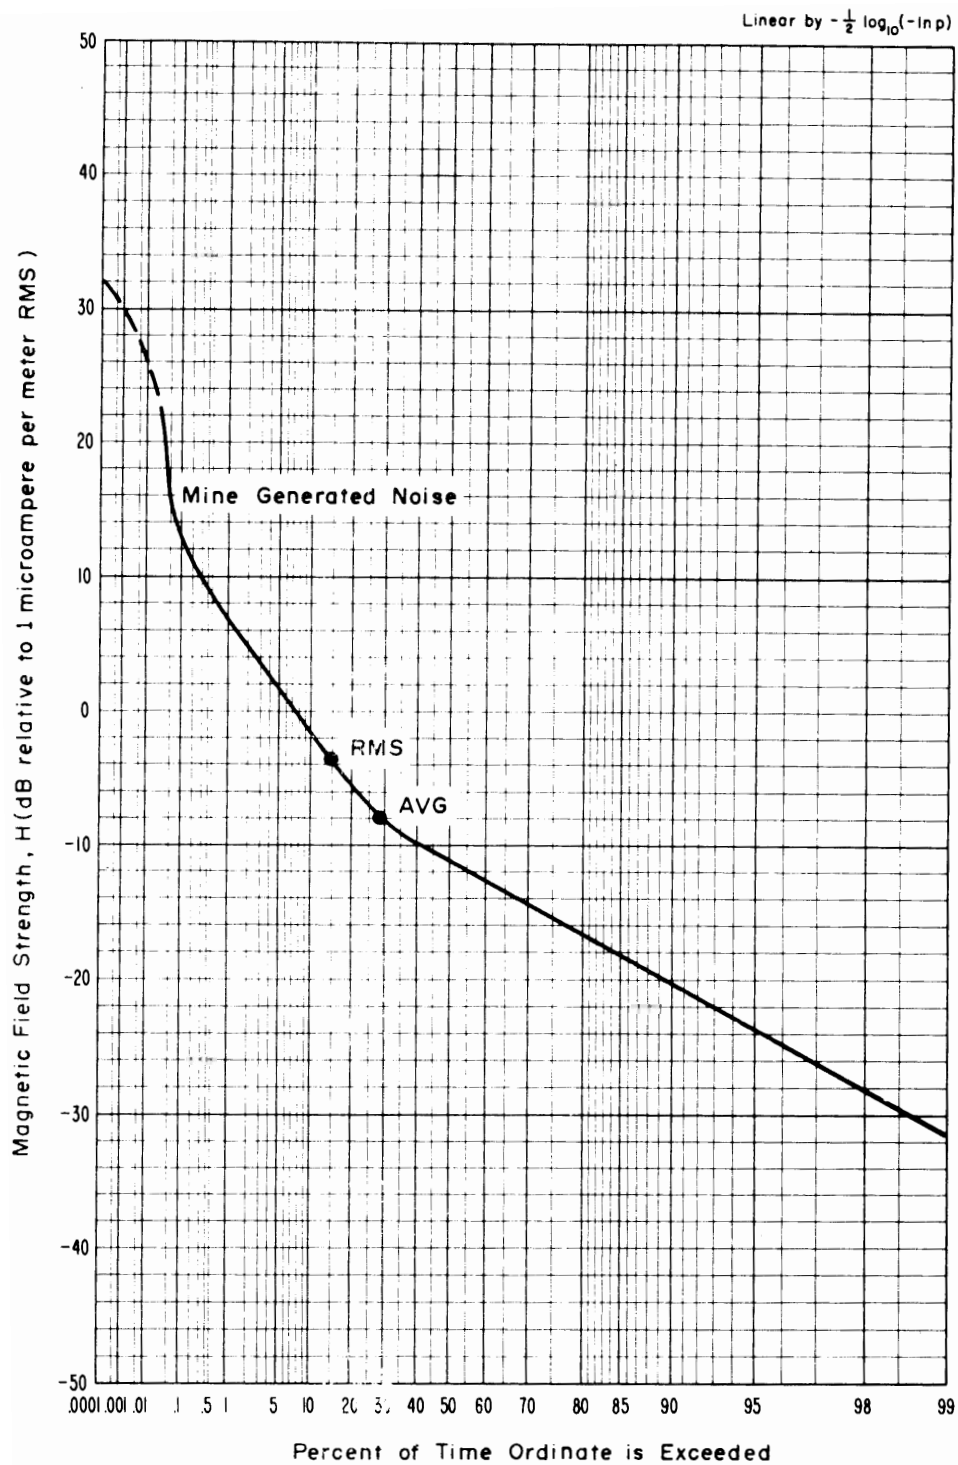
Figure 4-22 APD, 30 kHz, vertical component, 1.0 kHz predetection bandwidth, April 17, 1973, 1:15 p.m., Farley Panel, Itmann #3.

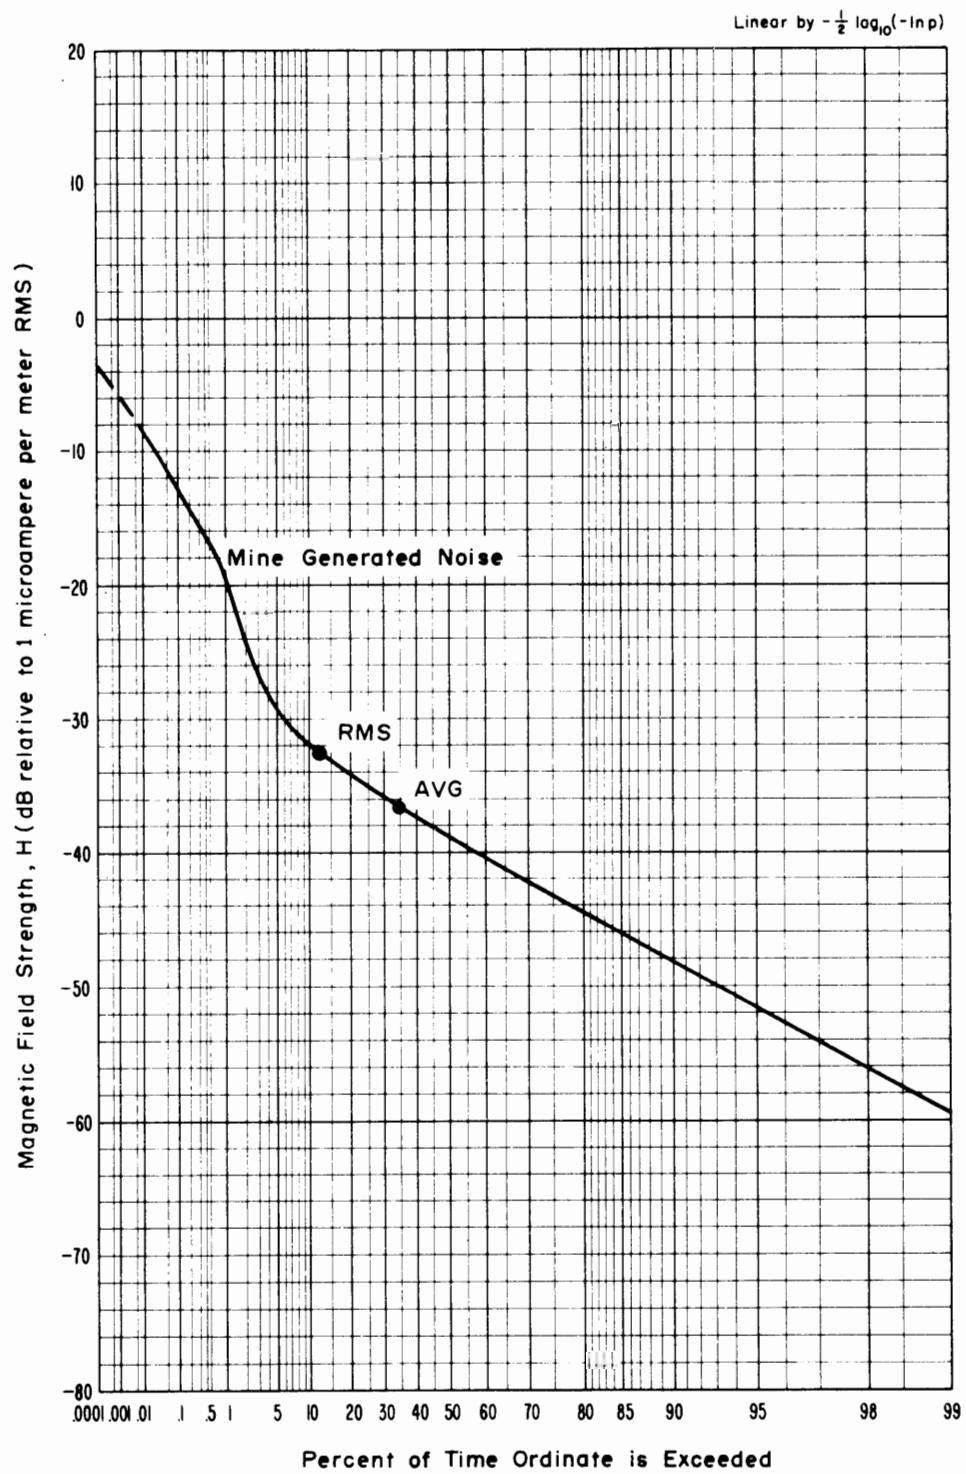
Figure 4-23 APD, 70 kHz, vertical component, 1.0 kHz predetection bandwidth, April 17, 1973, 2:00 p.m., Farley Panel, Itmann #3.
